INSPECT WITH HESS

Inspection Report

REPORT INTRODUCTION

Single Family (2 Story)

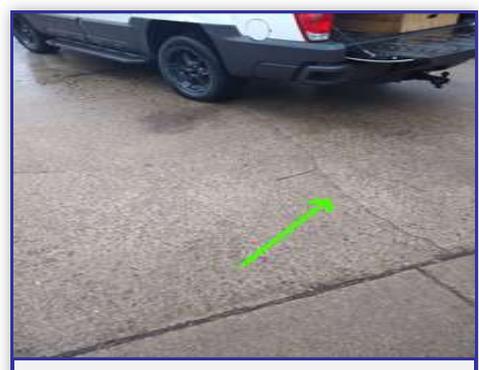
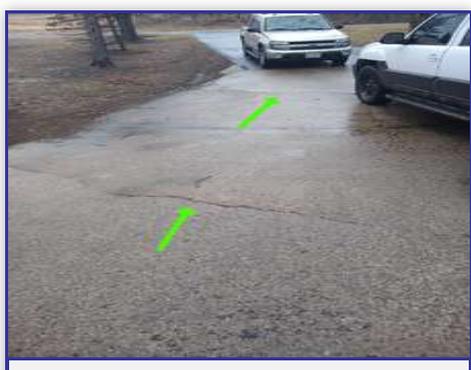
1.1

2.1.1 Common cracks Low

Common cracks were visible in the driveway.. If the these cracks are not sealed the areas will continue to get worse over time. Patching and sealing the affected areas with an exterior grade sealant, is recommended. If the the areas are not sealed, the deterioration will continue as a result.

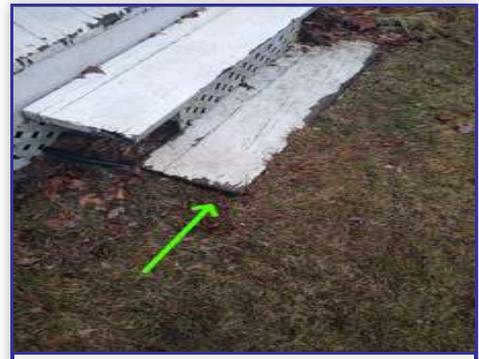
1.1 Wood rot noted

2.4.1 Deck on soil (Damage noted) Medium

One or more decks were installed at grade with visible wood rot or damage. The affected areas will need to be repaired as needed to industry standard by a professional deck repair contractor.

At the time of inspection, wood deterioration was found at one or more areas. The inspector recommends a professional contractor evaluate repair or replace necessary as all rotted wood should be replaced.

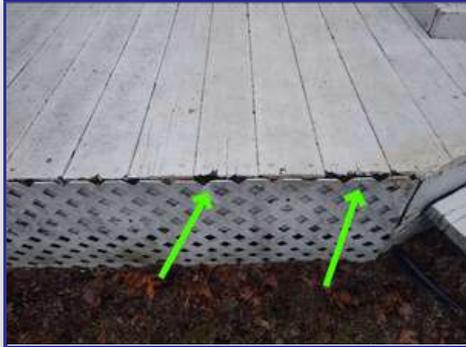
2.1 Paint before it gets worse and needs replacement

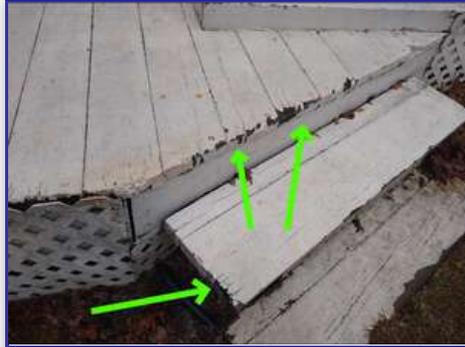
2.2 Structurally ok. Appears to be cosmetic at this time.

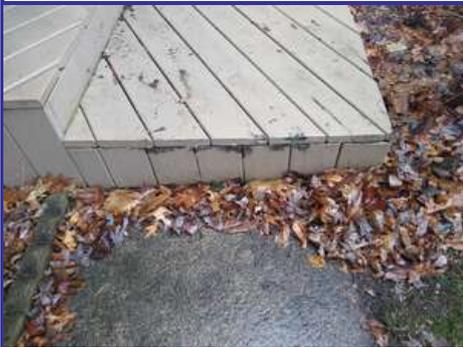
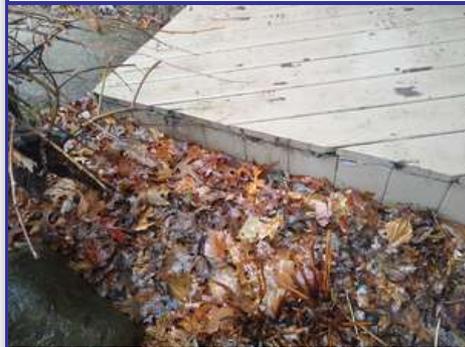
3.3.1 Paint failing some areas

At the time of inspection, paint or stain in some areas was failing (e.g. peeling, faded, worn, thinning). Siding and trim with a failing finish can be damaged by moisture. The Inspector recommends that the failing paint/stain area(s) be prep (e.g. clean, scrape, sand, prime, caulk) and repaint or re-stain, as needed, by a professional contractor, after needed siding or trim repairs are completed.

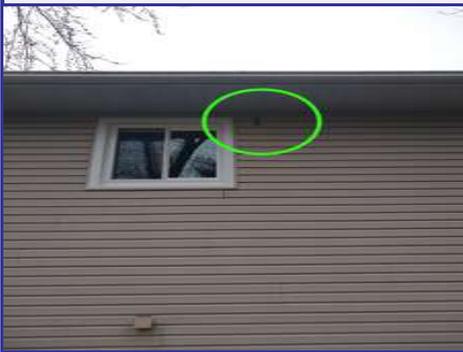
1.1

3.7.1 Loose or sagging vinyl siding

There were one or more areas of the vinyl siding were loose or sagging, which indicates failure of the fastening to the exterior. The Inspector recommends that the affected area(s) be evaluated, replaced or repaired, as needed, by a professional contractor.

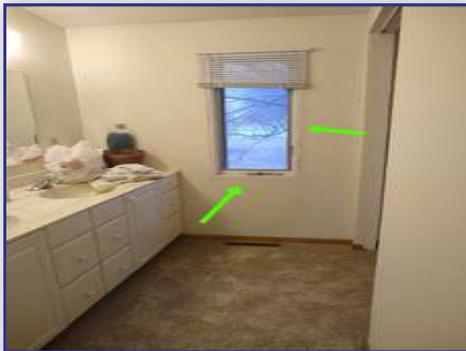
1.1

6.4.1 Trim missing

Interior trim is missing in one or more areas. The inspector recommends having a qualified contractor install trim where it is missing.

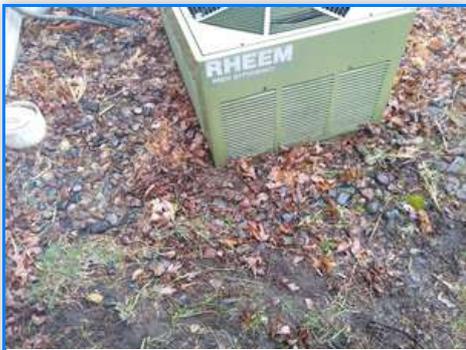
1.1

The AC compressor had settled into the soil. This can cause damage and corrosion to the enclosure. We recommend reposition the pad and AC unit on top of the soil. All work should be performed by a qualified HVAC contractor.

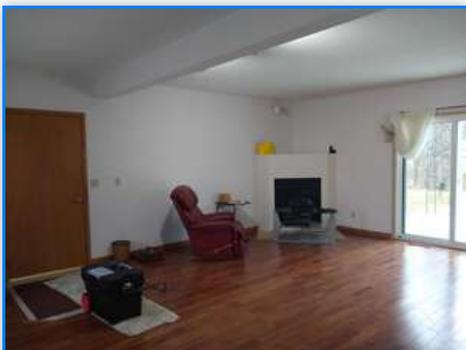
1.1

10.9.1 Gas fireplace. (Carbon monoxide detector missing)

Gas fireplaces are one potential cause of carbon monoxide poisoning. An improperly maintained or ventilated gas fireplace, however, can result in incomplete combustion, creating carbon monoxide, and causing this toxic gas to linger—putting those inside at risk of carbon monoxide poisoning. There was no carbon monoxide detector found near this gas fireplace. We recommend having one installed by a qualified HVAC contractor.

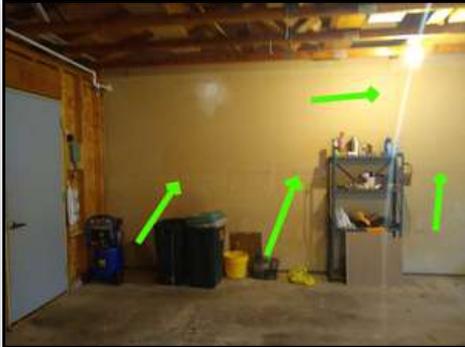
1.1 Mud and tap wall between garage and house

The homes garage walls joining the living area had no joint fire taping which is required by industry standard. The Inspector recommends that this corrected by a professional drywall contractor.

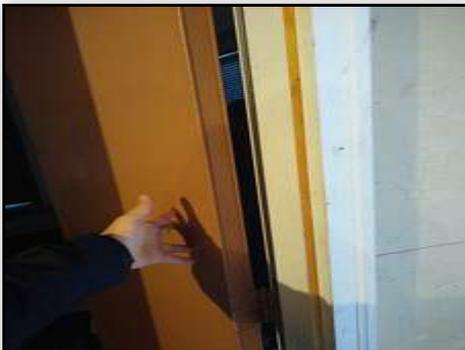
At the time of the inspection, the Door separating garage and home does not meet safety standards. Doors in firewalls must be at least 1 3/8-inch thick, metal/steel, or a 20-minute fire-rated door and must be self-closing, typically with a spring hinge. The Inspector recommends that the affected area(s) is evaluated, replaced or repaired, as needed, by a professional contractor.

2.1 No fire rating tag. Can't verify if fire rated door.

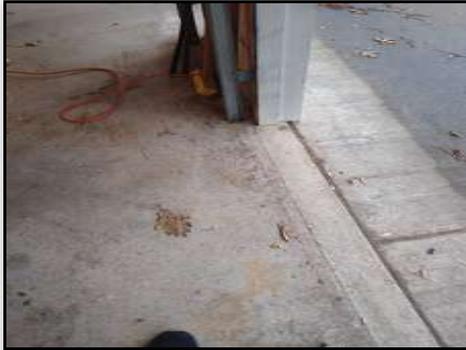
No infrared "photo eye" devices are installed for the vehicle door's electric door opener. They've been required on all vehicle door openers since 1993 to improve safety by triggering the vehicle door's auto-reverse feature without the need for the door to come in contact with the object, person or animal that's preventing it from closing. Recommend considering having a professional contractor to install for improved safety.

1.1 No photo sensors installed

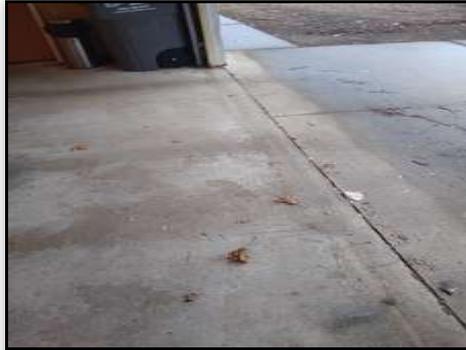
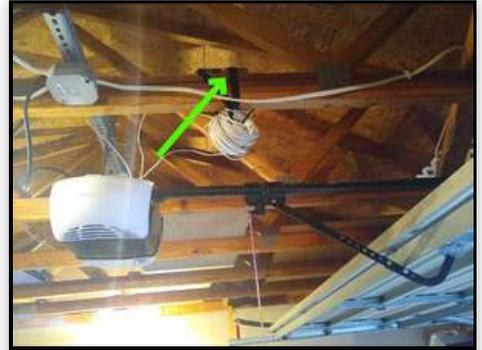
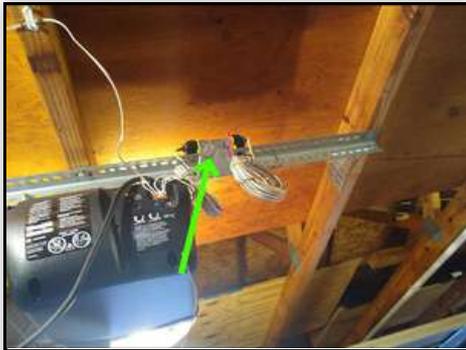
1.2 No photo sensors installed

1.3 sensors

1.4 sensors

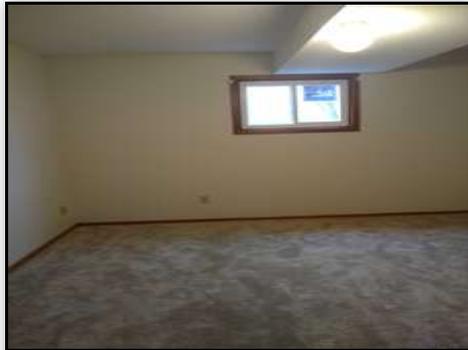
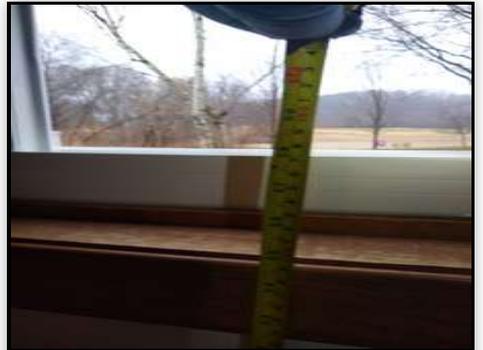
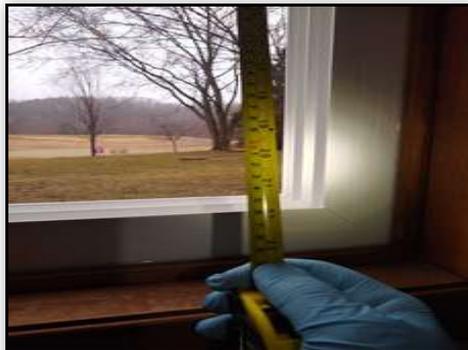
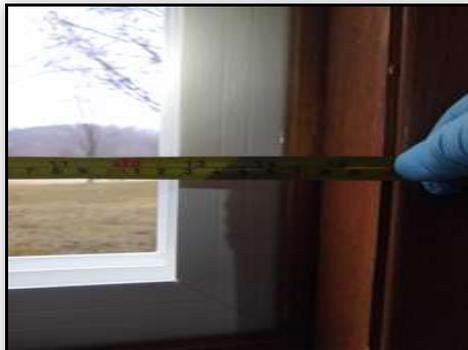
1. One or more bedrooms had windows that were too high above the floor. Unless a bedroom has an exterior entry door, at least one window requires adequate egress in the event of a fire or emergency to allow escape or to allow access by emergency personnel. The base of openings for egress windows should be a maximum of 44 inches above the floor. At a minimum, keep a chair or something that serves as a ladder below the window at all times. The inspector recommends having a qualified contractor repair or make modifications per standard building practices.

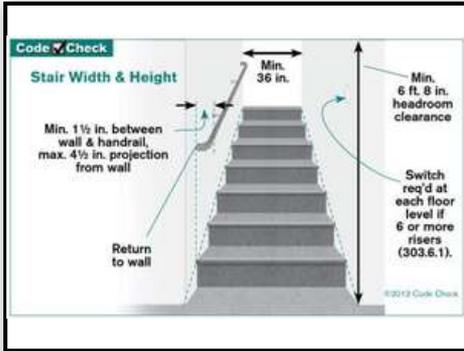
Staircase had no handrails. This is a safety hazard. Recommend a qualified contractor install a handrail.

1.1 Handrail example

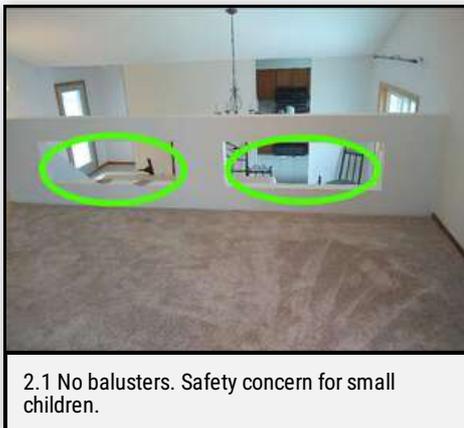
The baluster space is not up to industry standard. The space between balusters should not allow passage of a 4 3/8-inch sphere for child safety. Recommend a qualified handyman or original installer repair and bring up to current standard..

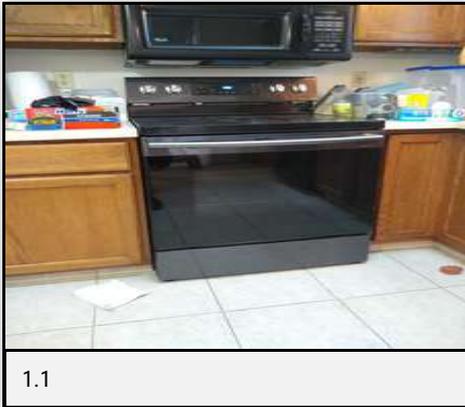
1.1

The oven anti-tilt device was not installed. This mechanism comes stock with the stove/range. This attaches to the wall and the oven is placed on it and attaches to it. This is a safety feature for children that tend to step on the bottom drawer to get something in a cabinet above the stove. It is a anti-tilt safety mechanism. We recommend that it be installed per the manufactures installation instructions.

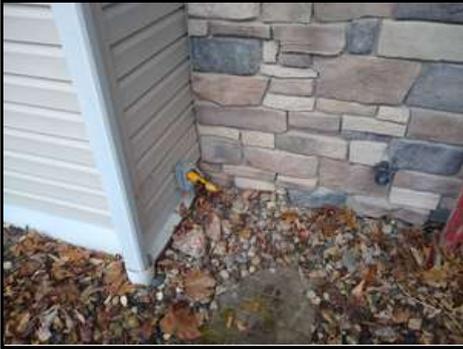
1.1

At the time of inspection, one or more exterior electrical receptacles had an open ground. The Inspector recommends that the affected area(s) be evaluated, replaced or repaired, as needed, by a professional contractor.

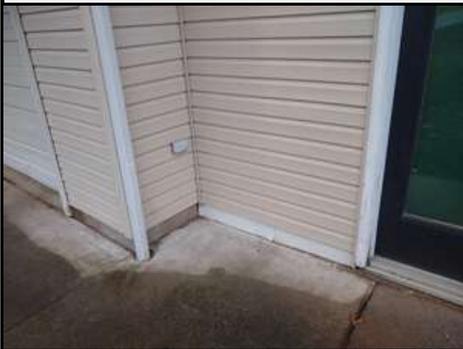
2.1

3.5.2 No test response to GFCI

At the time of inspection, one or more exterior (GFCI) electrical outlets, did not respond when the test button was clicked. The Inspector recommends that the GFCI receptacle be evaluated, replaced or repaired, as needed, by a professional electrical contractor. Should you consider doing the repair yourself, see the DIY linked video, to assist you in your decision.

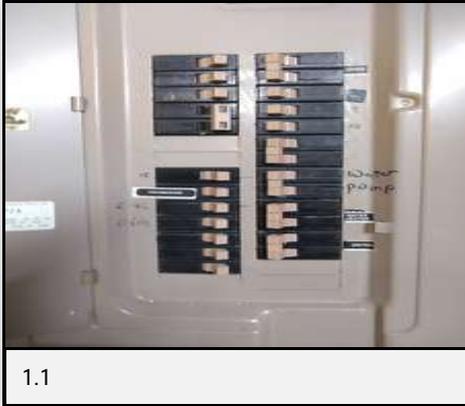
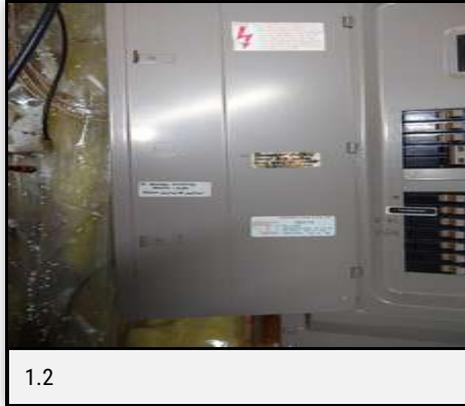
13.5.1 Legend (Missing,/Incomplete/Illegible)

The legend for circuit breakers or fuses in one or more panels were missing, incomplete, illegible or confusing. This is a potential shock or fire hazard in the event of an emergency when power needs to be turned off. Recommend correcting the legend so it's accurate, complete and legible. Evaluation by a qualified electrician may be necessary.

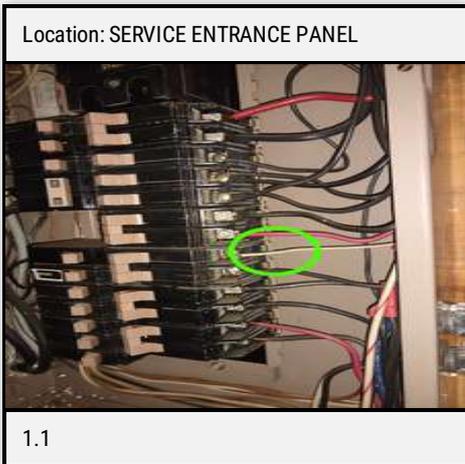
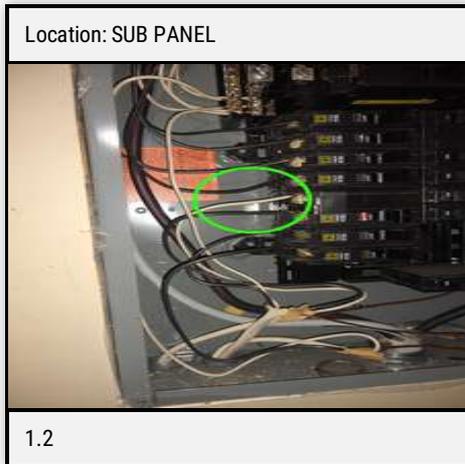
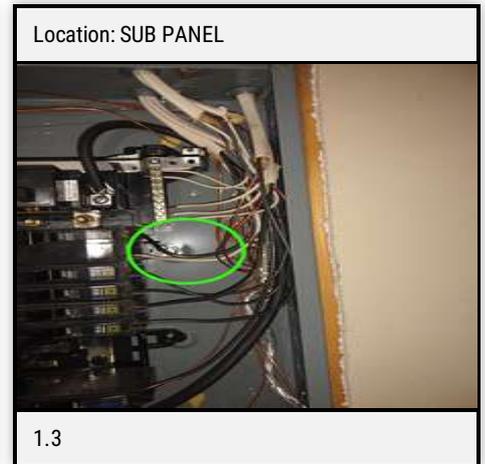
13.6.1 Re-identify wires

One or more energized conductors in panel had white, gray or green insulation. Insulation on energized conductors should be black or red in color to identify them as energized wires. Recommend that a qualified electrician re-identify wires per standard building practices. For example, by wrapping in black vinyl tape or marking with a black permanent marker.

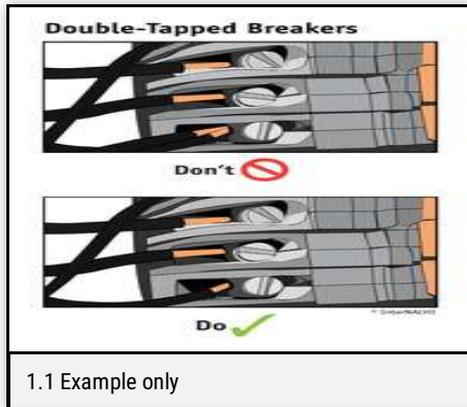
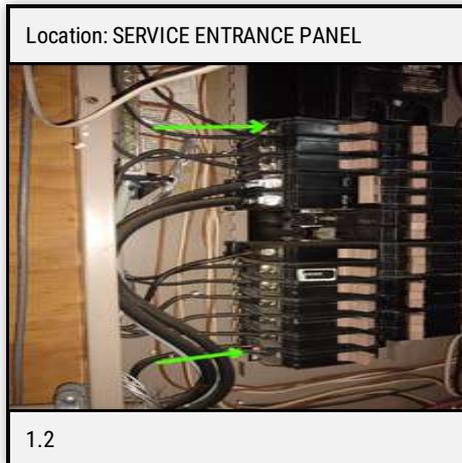
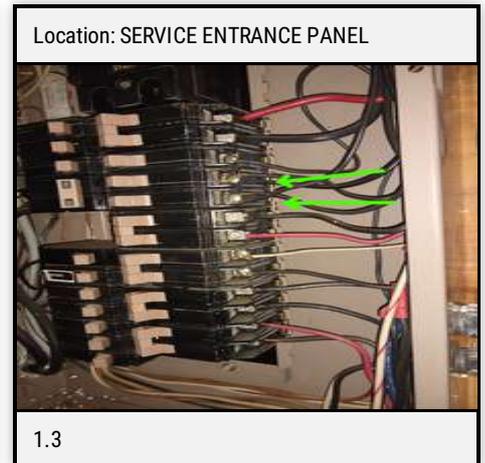
Two or more wires were installed in a breaker's lug, which is called "double tapped" and most breakers are intended for only one wire connection, as a lug is meant to secure one wire and the other can be loose, which poses a safety concern. There are some breakers designed for two wires, these do not appear to be correct for that application. Adding more breakers or "pig tailing" are both acceptable corrections. The inspector recommends a professional electrician correct as needed.

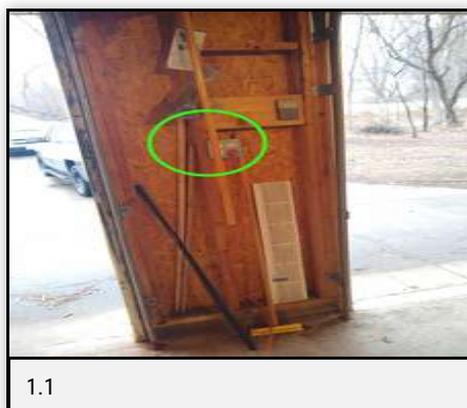
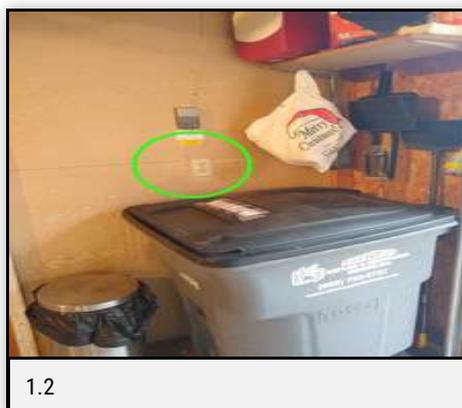
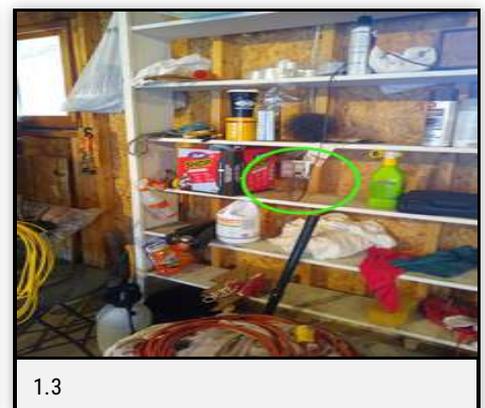
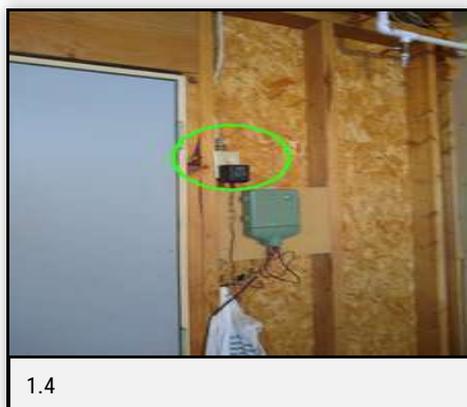
4.6.1 GFCI Protection Missing

A GFCI (ground fault circuit interrupter) outlet is a device that adds a greater level of safety by reducing the risk of electric shock. Modern building standards require GFCI protection at ALL kitchens, bathrooms, laundry areas, garages, and exterior areas. One or more locations at this property were noted as not having GFCI protection or the inspector was unable to verify if GFCI protection existed at these locations. Adoption of GFCI outlets was generally phased in over numerous years/decades. Recommend client evaluate upgrading these areas to GFCI protection at their discretion. General guidelines for GFCI-protected receptacles include the following locations: Outdoors (since 1973) Bathrooms (since 1975) Garages (since 1978) Kitchens (since 1987) Crawl spaces and unfinished basements (since 1990) Wet bar sinks (since 1993) Laundry and utility sinks (since 2005)

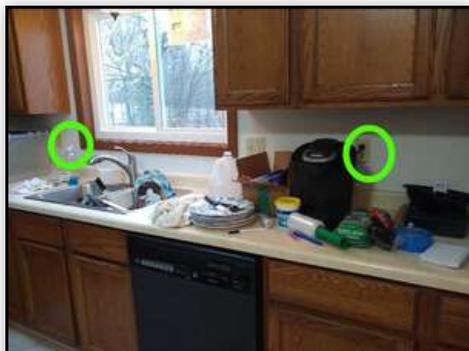
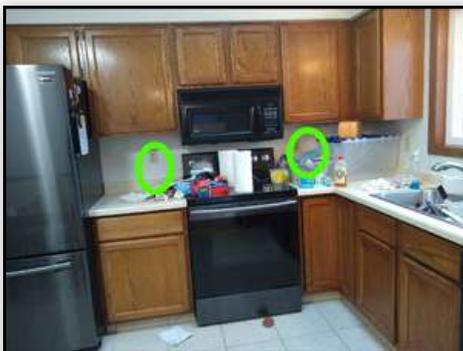
7.1.1 GFCI Protection Missing

A GFCI (ground fault circuit interrupter) outlet is a device that adds a greater level of safety by reducing the risk of electric shock. Modern building standards require GFCI protection at ALL kitchens, bathrooms, laundry areas, garages, and exterior areas. One or more locations at this property were noted as not having GFCI protection or the inspector was unable to verify if GFCI protection existed at these locations. Adoption of GFCI outlets was generally phased in over numerous years/decades. Recommend client evaluate upgrading these areas to GFCI protection at their discretion. General guidelines for GFCI-protected receptacles include the following locations: Outdoors (since 1973) Bathrooms (since 1975) Garages (since 1978) Kitchens (since 1987) Crawl spaces and unfinished basements (since 1990) Wet bar sinks (since 1993) Laundry and utility sinks (since 2005)

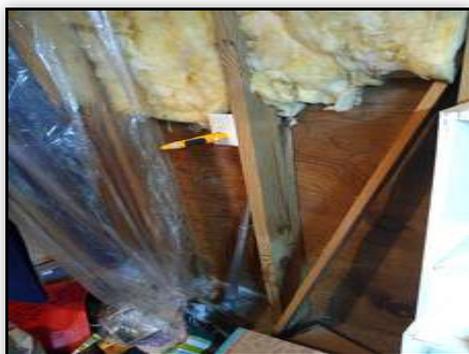
1.1

One or more electrical outlet(s) in the basement/crawl space had hot and neutral wires reversed. The Inspector recommends that the affected area(s) is evaluated, replaced or repaired, as needed, by a professional electrical contractor.

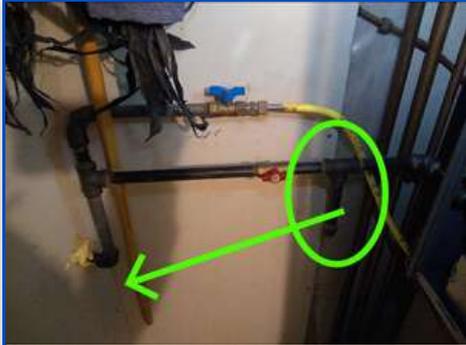
There was no gas line drip leg installed on the furnace gas line. These are installed to prevent partials or other contaminants from entering the gas valve/system that can damaged the unit. The inspector recommends that the gas line be evaluated and repaired by a professional plumbing contractor.

1.1 Incorrect install

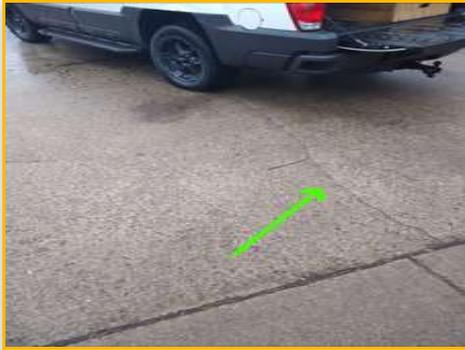
1.1

2.1.1 Common cracks

Common cracks were visible in the driveway.. If the these cracks are not sealed the areas will continue to get worse over time. Patching and sealing the affected areas with an exterior grade sealant, is recommended. If the the areas are not sealed, the deterioration will continue as a result.

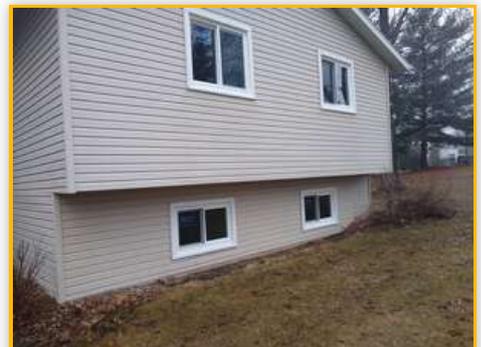
1.3

The soil or grading of the exterior was neutral and/or sloped toward the home in one or more areas where water can pool along the foundation or underneath. These areas should be monitored regularly. If water accumulates in areas, recommend soil is graded down and away from the foundation with a slope at least 1 inch per horizontal foot for at least 6 feet out from home.

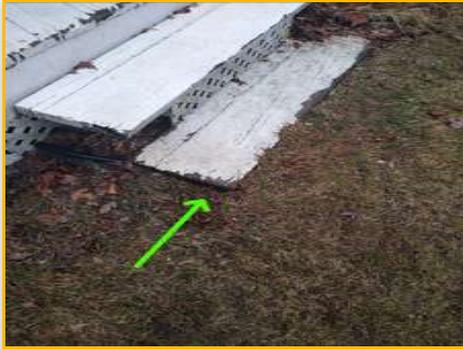
One or more decks were installed at grade with visible wood rot or damage. The affected areas will need to be repaired as needed to industry standard by a professional deck repair contractor.

1.1 Wood rot noted

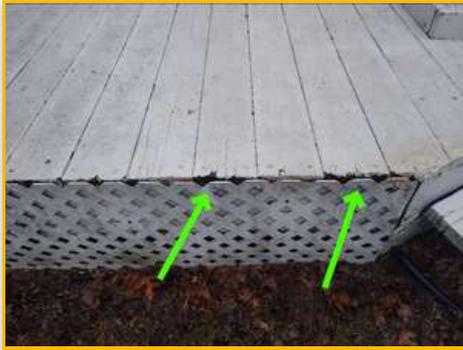
At the time of inspection, wood deterioration was found at one or more areas. The inspector recommends a professional contractor evaluate repair or replace necessary as all rotted wood should be replaced.

2.1 Paint before it gets worse and needs replacement

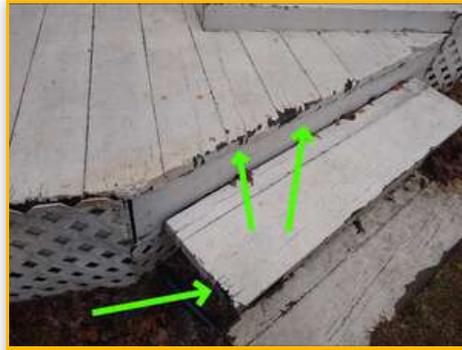
2.2 Structurally ok. Appears to be cosmetic at this time.

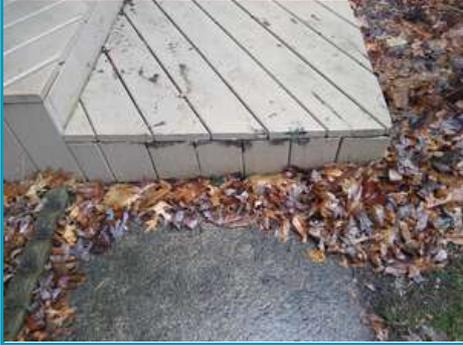
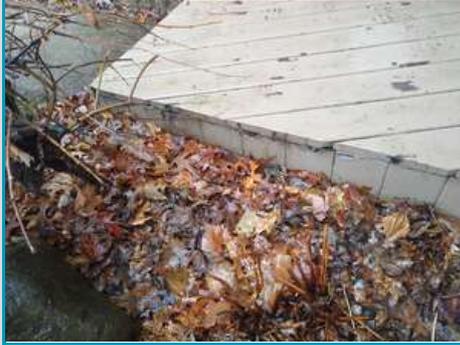
At the time of inspection, paint or stain in some areas was failing (e.g. peeling, faded, worn, thinning). Siding and trim with a failing finish can be damaged by moisture. The Inspector recommends that the failing paint/stain area(s) be prep (e.g. clean, scrape, sand, prime, caulk) and repaint or re-stain, as needed, by a professional contractor, after needed siding or trim repairs are completed.

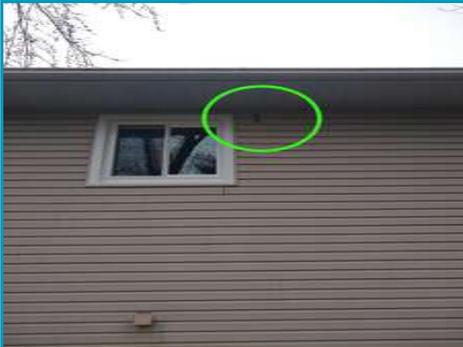
1.1

There were one or more areas of the vinyl siding were loose or sagging, which indicates failure of the fastening to the exterior. The Inspector recommends that the affected area(s) be evaluated, replaced or repaired, as needed, by a professional contractor.

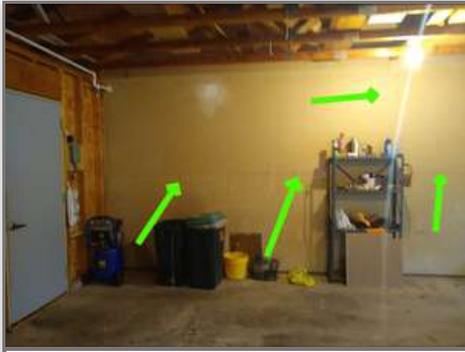
The homes garage walls joining the living area had no joint fire taping which is required by industry standard. The Inspector recommends that this corrected by a professional drywall contractor.

1.1 Mud and tap wall between garage and house

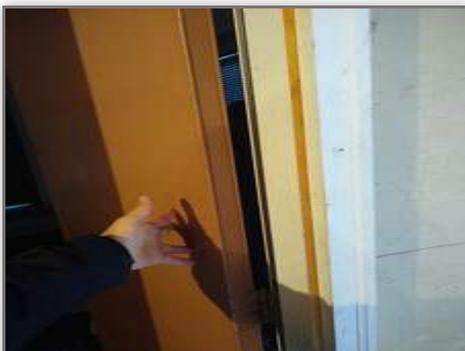
At the time of the inspection, the Door separating garage and home does not meet safety standards. Doors in firewalls must be at least 1 3/8-inch thick, metal/steel, or a 20-minute fire-rated door and must be self-closing, typically with a spring hinge. The Inspector recommends that the affected area(s) is evaluated, replaced or repaired, as needed, by a professional contractor.

2.1 No fire rating tag. Can't verify if fire rated door.

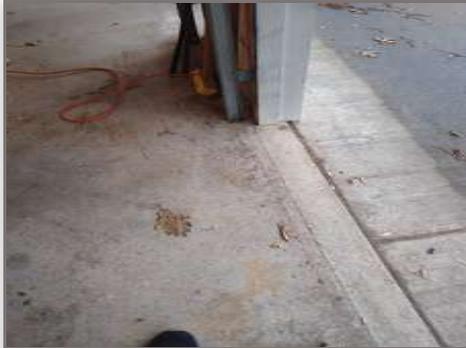
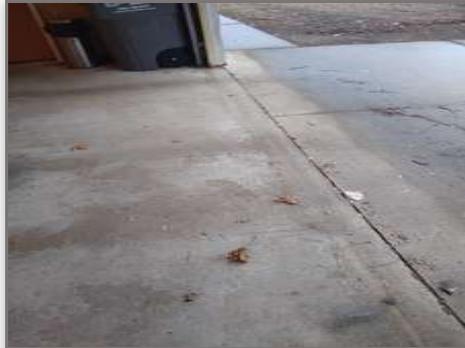
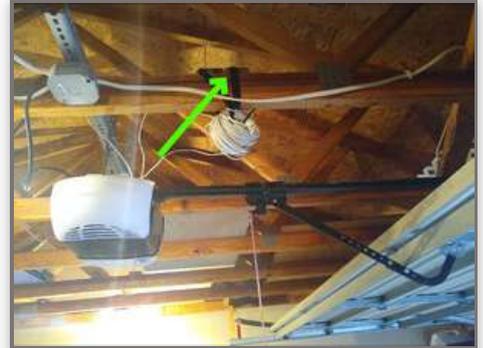
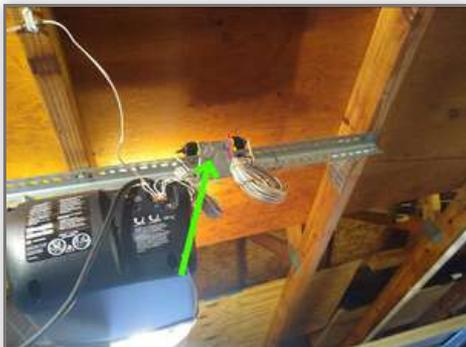
No infrared "photo eye" devices are installed for the vehicle door's electric door opener. They've been required on all vehicle door openers since 1993 to improve safety by triggering the vehicle door's auto-reverse feature without the need for the door to come in contact with the object, person or animal that's preventing it from closing. Recommend considering having a professional contractor to install for improved safety.

1.1 No photo sensors installed

1.2 No photo sensors installed

1.3 sensors

1.4 sensors

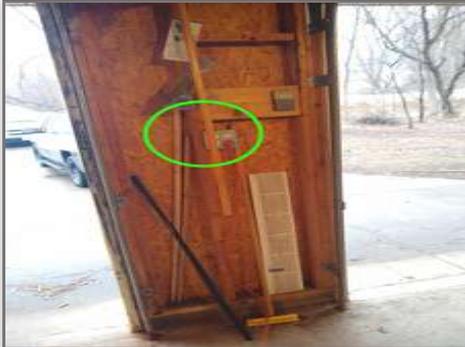
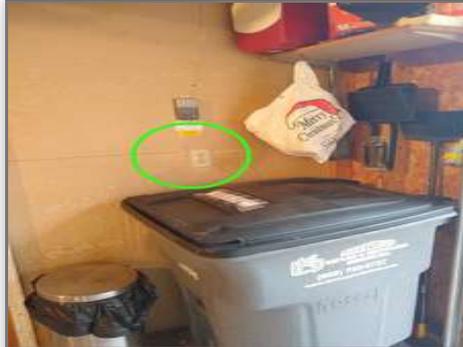
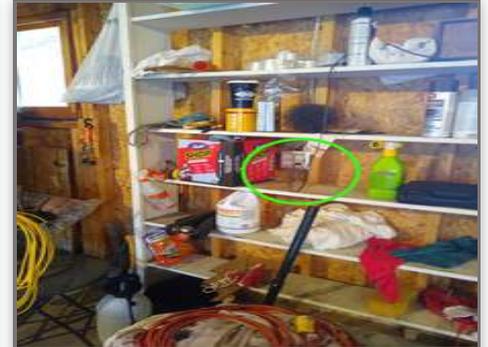
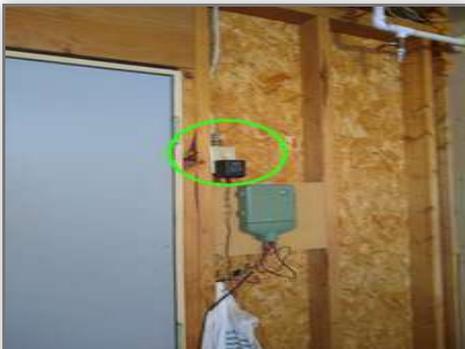
A GFCI (ground fault circuit interrupter) outlet is a device that adds a greater level of safety by reducing the risk of electric shock. Modern building standards require GFCI protection at ALL kitchens, bathrooms, laundry areas, garages, and exterior areas. One or more locations at this property were noted as not having GFCI protection or the inspector was unable to verify if GFCI protection existed at these locations. Adoption of GFCI outlets was generally phased in over numerous years/decades. Recommend client evaluate upgrading these areas to GFCI protection at their discretion. General guidelines for GFCI-protected receptacles include the following locations: Outdoors (since 1973) Bathrooms (since 1975) Garages (since 1978) Kitchens (since 1987) Crawl spaces and unfinished basements (since 1990) Wet bar sinks (since 1993) Laundry and utility sinks (since 2005)

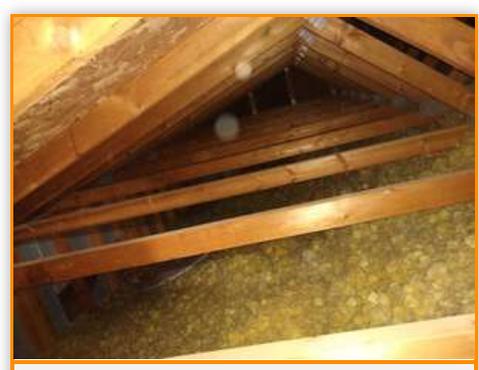
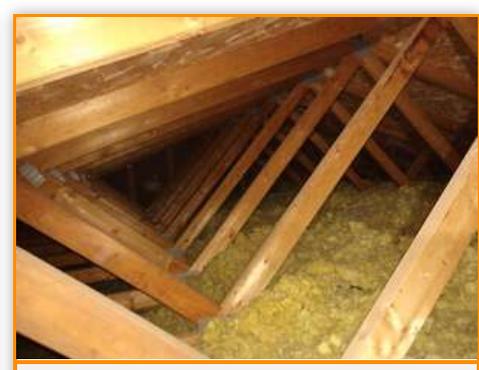
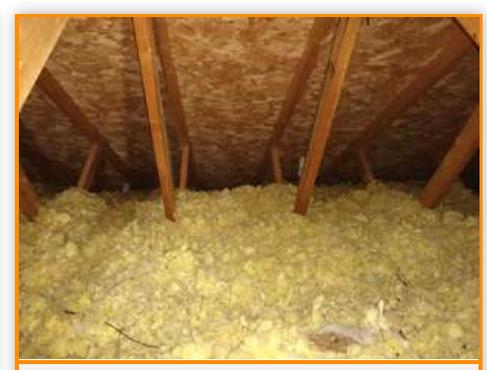
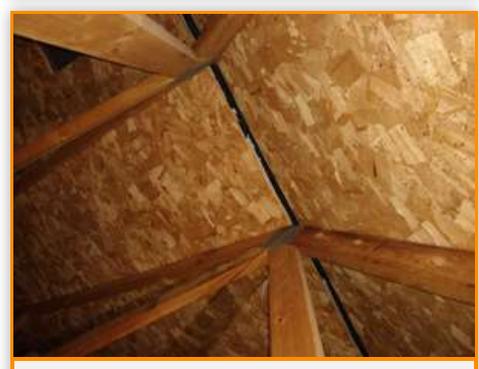
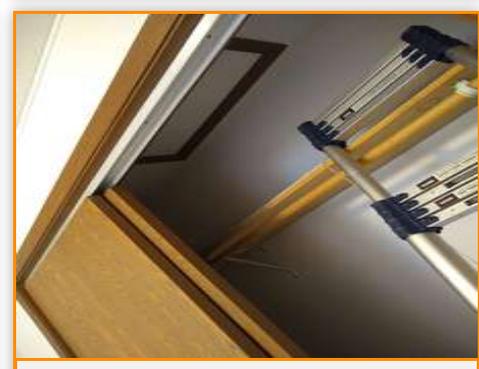
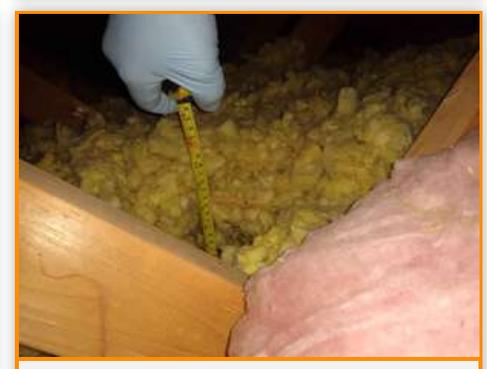
Attic general condition

Pics/videos of the attic space for your records.

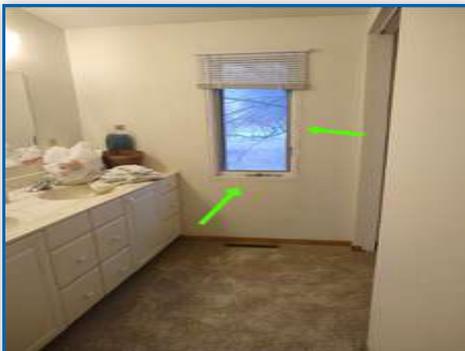
1.1

Interior trim is missing in one or more areas. The inspector recommends having a qualified contractor install trim where it is missing.

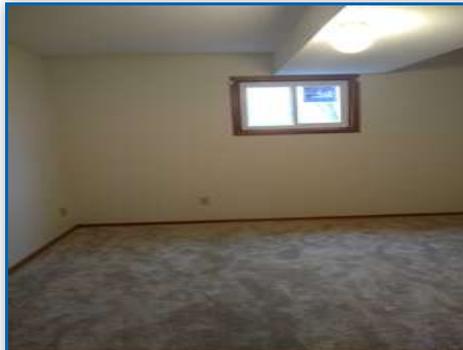
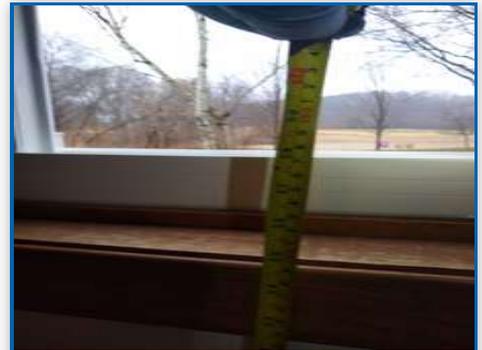
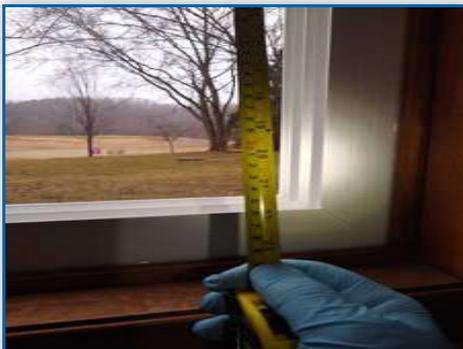
1. One or more bedrooms had windows that were too high above the floor. Unless a bedroom has an exterior entry door, at least one window requires adequate egress in the event of a fire or emergency to allow escape or to allow access by emergency personnel. The base of openings for egress windows should be a maximum of 44 inches above the floor. At a minimum, keep a chair or something that serves as a ladder below the window at all times. The inspector recommends having a qualified contractor repair or make modifications per standard building practices.

2. One or more bedrooms had windows that were too small. Unless a bedroom has an exterior entry door, at least one window requires adequate egress in the event of a fire or emergency to allow escape or to allow access by emergency personnel. Such windows should have a minimum open width of 20 inches and a minimum open height of 24 inches. Grade floor egress windows should have a net clear opening of 5 square feet and other egress windows should have a net clear opening of 5.7 square feet. Recommend that a qualified contractor repair or make modifications per standard building practices.

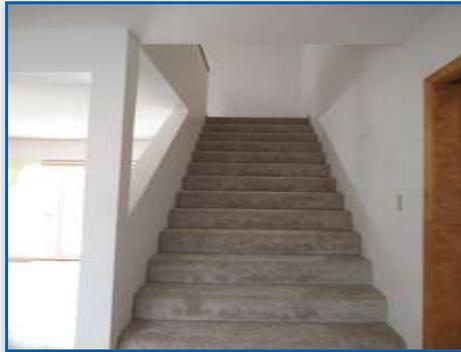
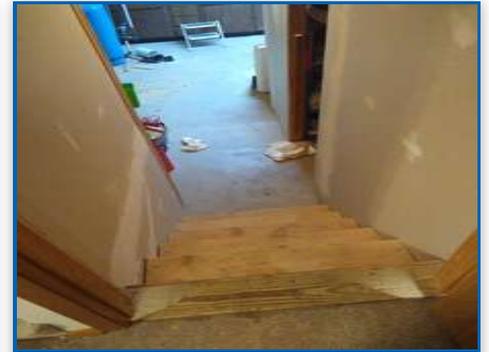
Staircase had no handrails. This is a safety hazard. Recommend a qualified contractor install a handrail.

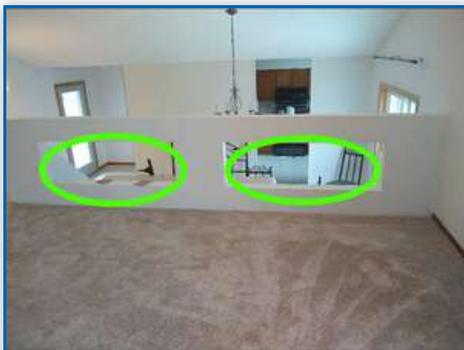
The baluster space is not up to industry standard. The space between balusters should not allow passage of a 4 3/8-inch sphere for child safety. Recommend a qualified handyman or original installer repair and bring up to current standard..

2.1 No balusters. Safety concern for small children.

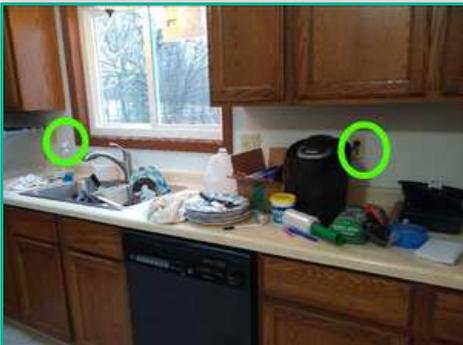
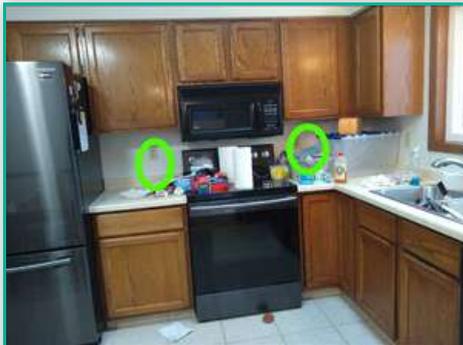
A GFCI (ground fault circuit interrupter) outlet is a device that adds a greater level of safety by reducing the risk of electric shock. Modern building standards require GFCI protection at ALL kitchens, bathrooms, laundry areas, garages, and exterior areas. One or more locations at this property were noted as not having GFCI protection or the inspector was unable to verify if GFCI protection existed at these locations. Adoption of GFCI outlets was generally phased in over numerous years/decades. Recommend client evaluate upgrading these areas to GFCI protection at their discretion. General guidelines for GFCI-protected receptacles include the following locations: Outdoors (since 1973) Bathrooms (since 1975) Garages (since 1978) Kitchens (since 1987) Crawl spaces and unfinished basements (since 1990) Wet bar sinks (since 1993) Laundry and utility sinks (since 2005)

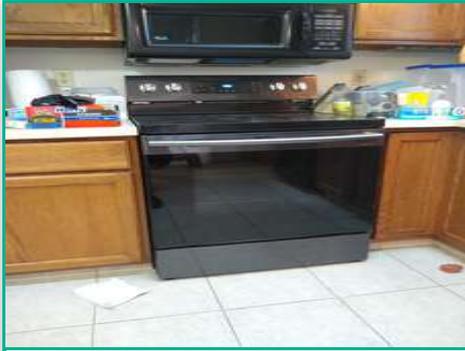
1.1

The oven anti-tilt device was not installed. This mechanism comes stock with the stove/range. This attaches to the wall and the oven is placed on it and attaches to it. This is a safety feature for children that tend to step on the bottom drawer to get something in a cabinet above the stove. It is a anti-tilt safety mechanism. We recommend that it be installed per the manufactures installation instructions.

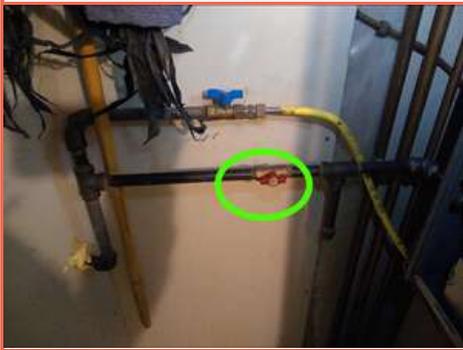
1.4 2nd Furnace fuel shut off

Location: 1ST FLOOR

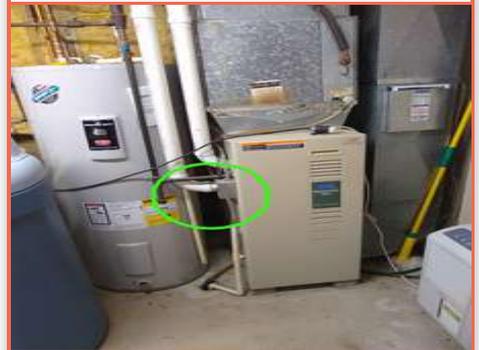
1.6 Furnace shut off switch

Location: BASEMENT

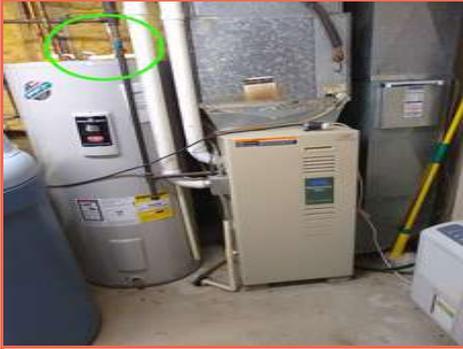
1.7 Furnace fuel shut off

Location: BASEMENT

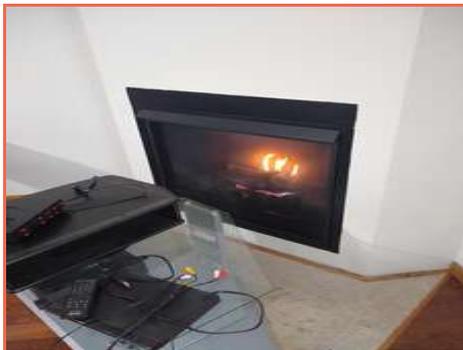
1.2 Fireplace responded to the call for heat

Location: MAIN FLOOR UTILITY ROOM

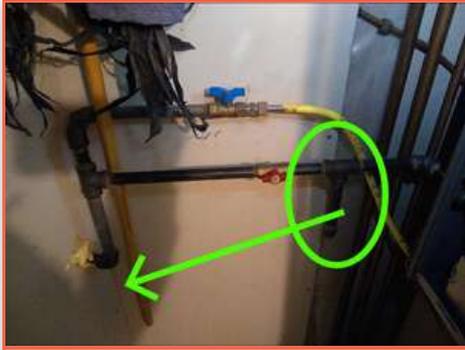
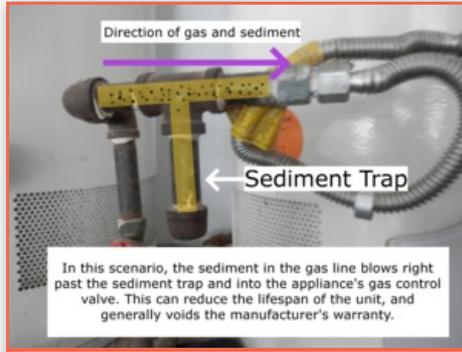
There was no gas line drip leg installed on the furnace gas line. These are installed to prevent partials or other contaminants from entering the gas valve/system that can damaged the unit. The inspector recommends that the gas line be evaluated and repaired by a professional plumbing contractor.

1.1 Incorrect install

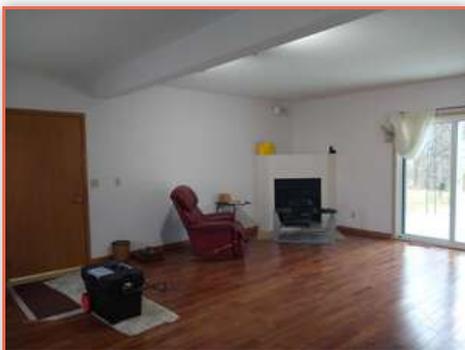
1.1

10.9.1 Gas fireplace. (Carbon monoxide detector missing)

Gas fireplaces are one potential cause of carbon monoxide poisoning. An improperly maintained or ventilated gas fireplace, however, can result in incomplete combustion, creating carbon monoxide, and causing this toxic gas to linger—putting those inside at risk of carbon monoxide poisoning. There was no carbon monoxide detector found near this gas fireplace. We recommend having one installed by a qualified HVAC contractor.

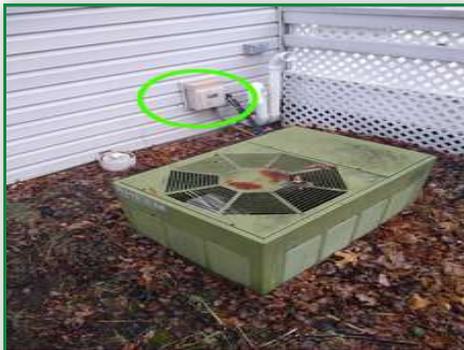
1.1 AC 1 disconnect location

The air conditioner disconnect was located near the air conditioner. This is the disconnect that will shut the equipment off in an emergency. Central air condition maintenance and precautions:

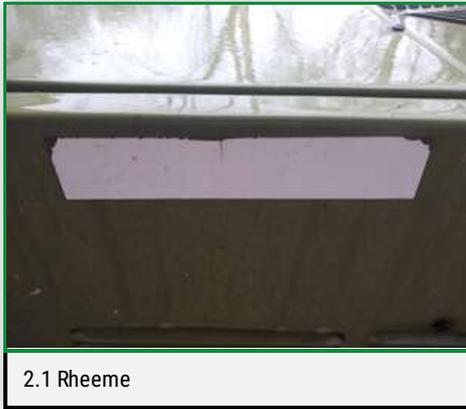
2.1 Rheeme

Unable to determine the size and age of the unit due to the label being faded or missing at the time of inspection. Ask the seller the if they are aware of the age of the unit to determine an estimated life span of the unit.

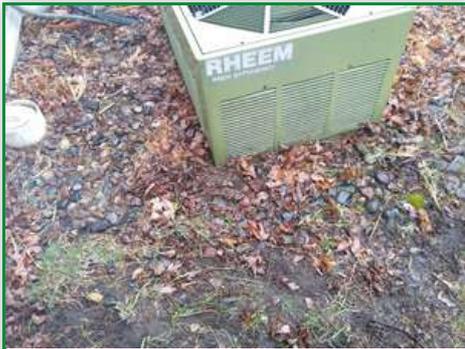
1.1

The AC compressor had settled into the soil. This can cause damage and corrosion to the enclosure. We recommend reposition the pad and AC unit on top of the soil. All work should be performed by a qualified HVAC contractor.

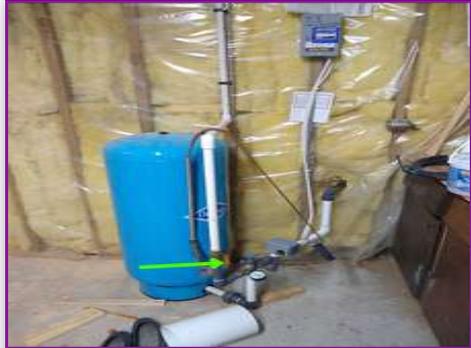
1.2 Main water shut off

The main water shut off location is in the discription in the photo below. This is the area where you can shut off the water to your home if you need to do repairs or in an emergency.

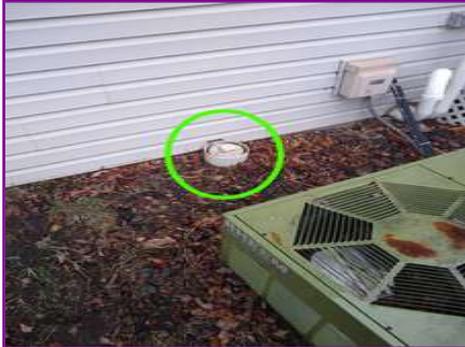
2.1

The sewer clean-out is located in the home and is identified in the photo description. It is not recommended to flush feminine hygiene products down a sanitary drain line or toilet. Materials can catch on tree roots or cracks creating a blockage and result in costly repairs to clean out the obstructions. Also is not recommended to dump cooking grease or oils down sinks or sanitary drains. Grease and oils have a tendency to cool and will collect creating a build-up and/or blockage in the main sewer line creating costly repairs.

Location: EXTERIOR REAR

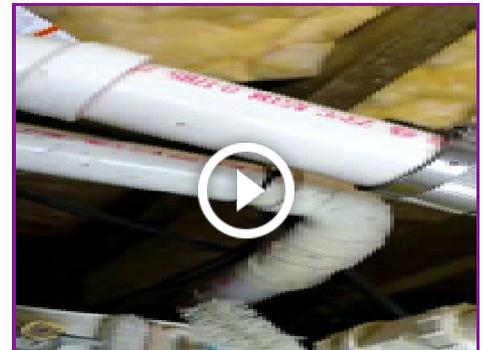
5.3 Responded to testing

When we verify if a sump pump is working, typically we will just manipulate the pump by providing power to it. This is usually done by lifting the float switch manually or by plugging the pump in directly and bypassing the float switch. This is done because of time constraints. We recommend following the manufacturers guidelines for testing your pump.

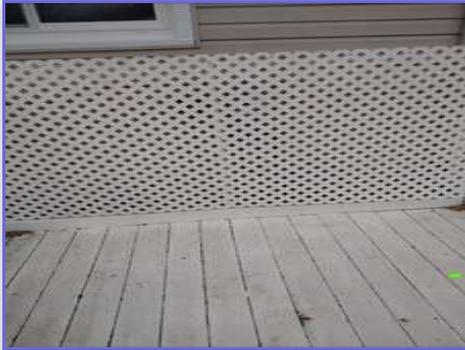
1.1

The electrical meter was blocked/covered and it's condition could not be confirmed by the inspector.

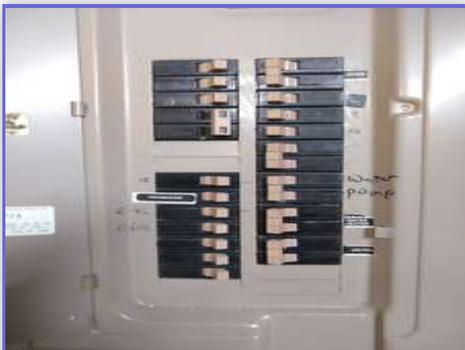
1.1

The legend for circuit breakers or fuses in one or more panels were missing, incomplete, illegible or confusing. This is a potential shock or fire hazard in the event of an emergency when power needs to be turned off. Recommend correcting the legend so it's accurate, complete and legible. Evaluation by a qualified electrician may be necessary.

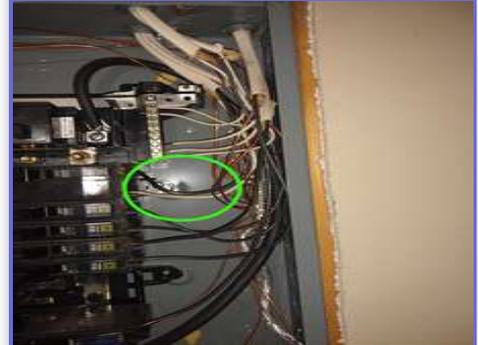
1.3

One or more energized conductors in panel had white, gray or green insulation. Insulation on energized conductors should be black or red in color to identify them as energized wires. Recommend that a qualified electrician re-identify wires per standard building practices. For example, by wrapping in black vinyl tape or marking with a black permanent marker.

Location: SUB PANEL

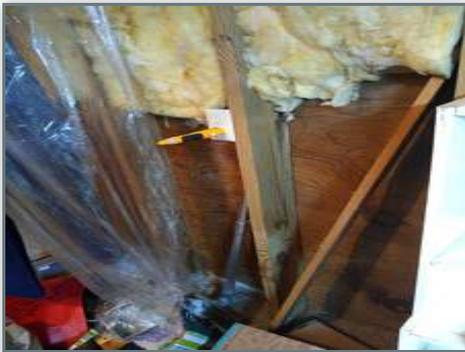
1.1

One or more electrical outlet(s) in the basement/crawl space had hot and neutral wires reversed. The Inspector recommends that the affected area(s) is evaluated, replaced or repaired, as needed, by a professional electrical contractor.
